US Army Corps  
of Engineers®  
Engineer Research and  
Development Center

## **Periodic Inspections of Hilo, Kahului, Laupahoehoe, and Nawiliwili Breakwaters, Hawaii**

Armor Unit Monitoring for Period 2001-2005

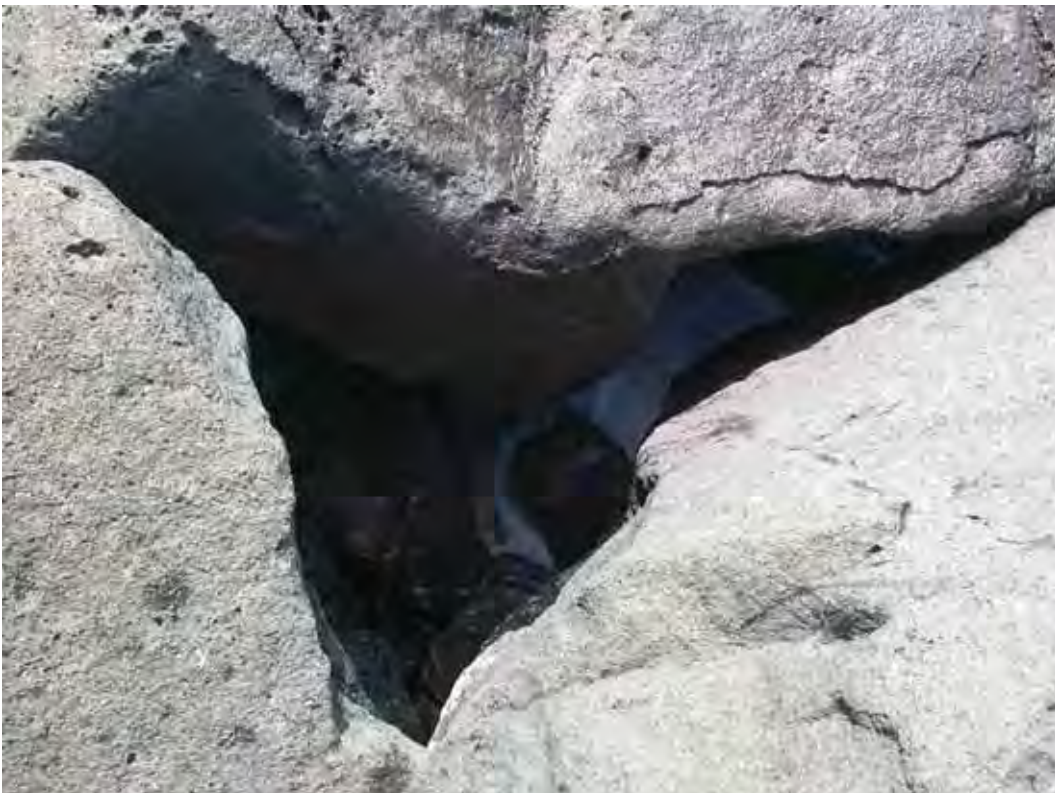
Figure A47. Damage location 51, sta 52+60, bridging.

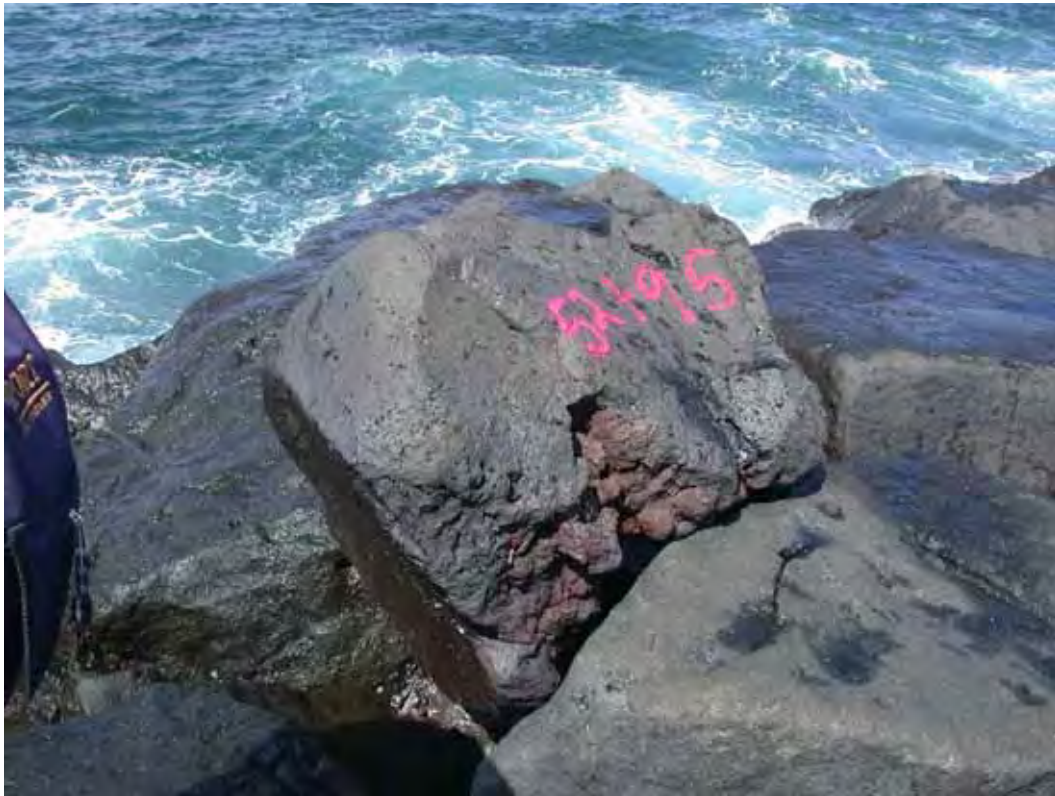
Figure A48. Damage location 52, sta 52+95, ocean side, perched armor stone.

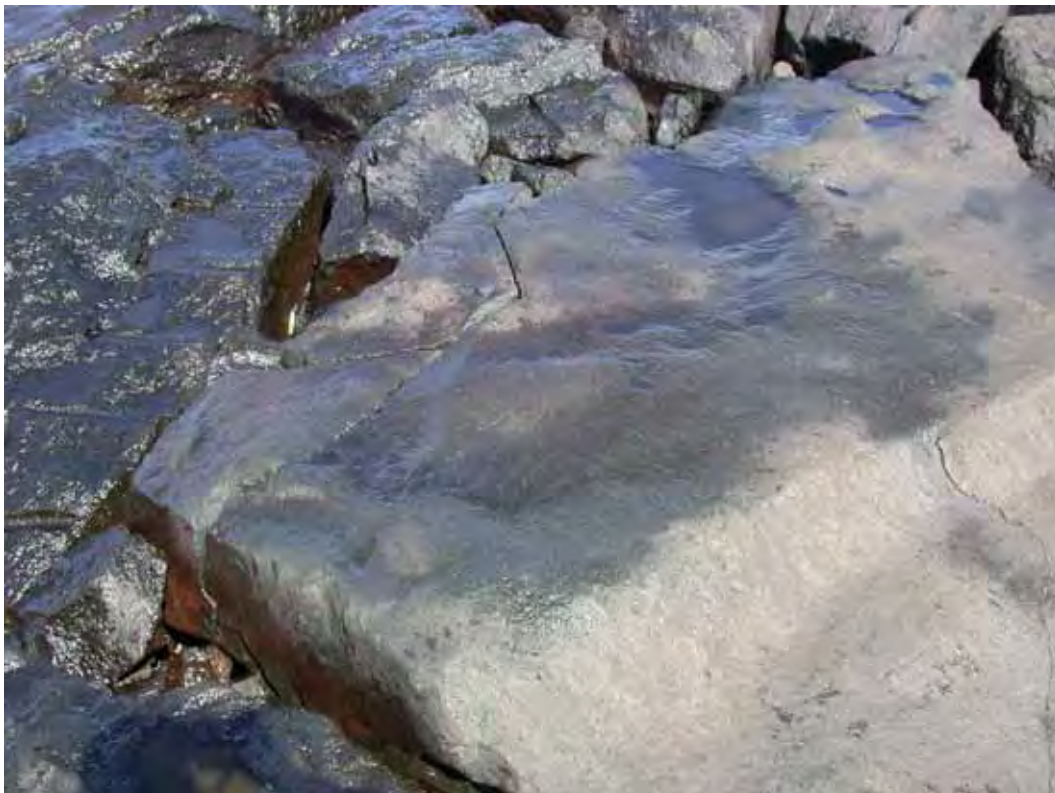
Figure A49. Damage location 53, sta 54+30, broken stone on crest.

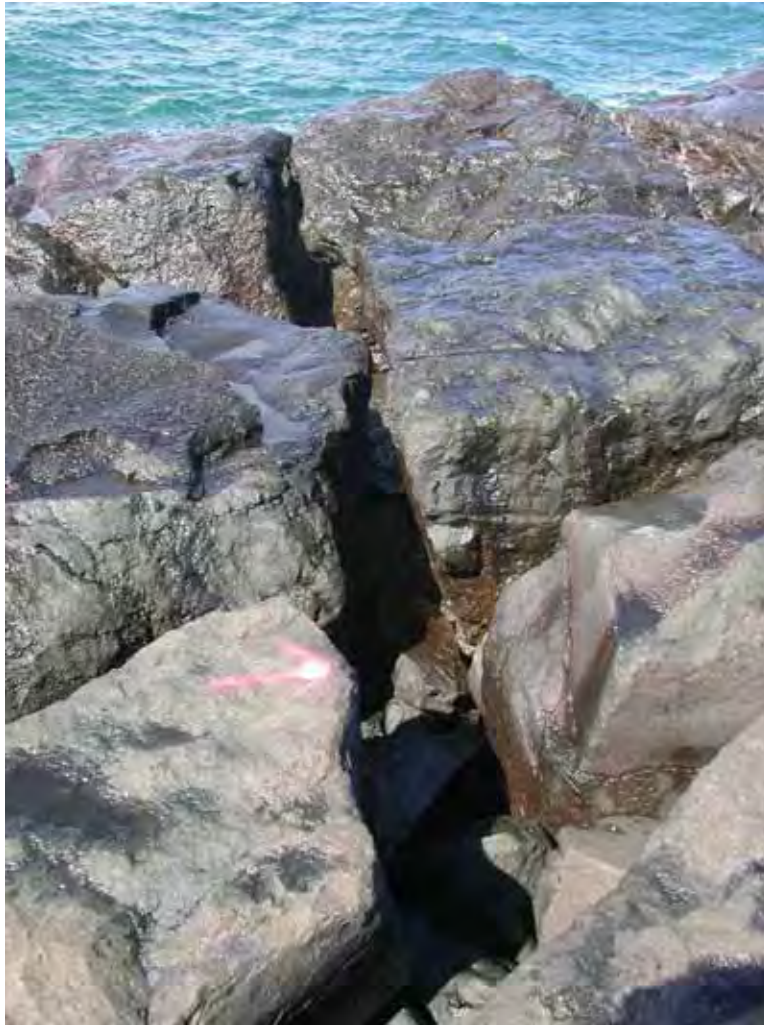
Figure A50. Damage location 54, sta 56+10, ocean side, void at crest.

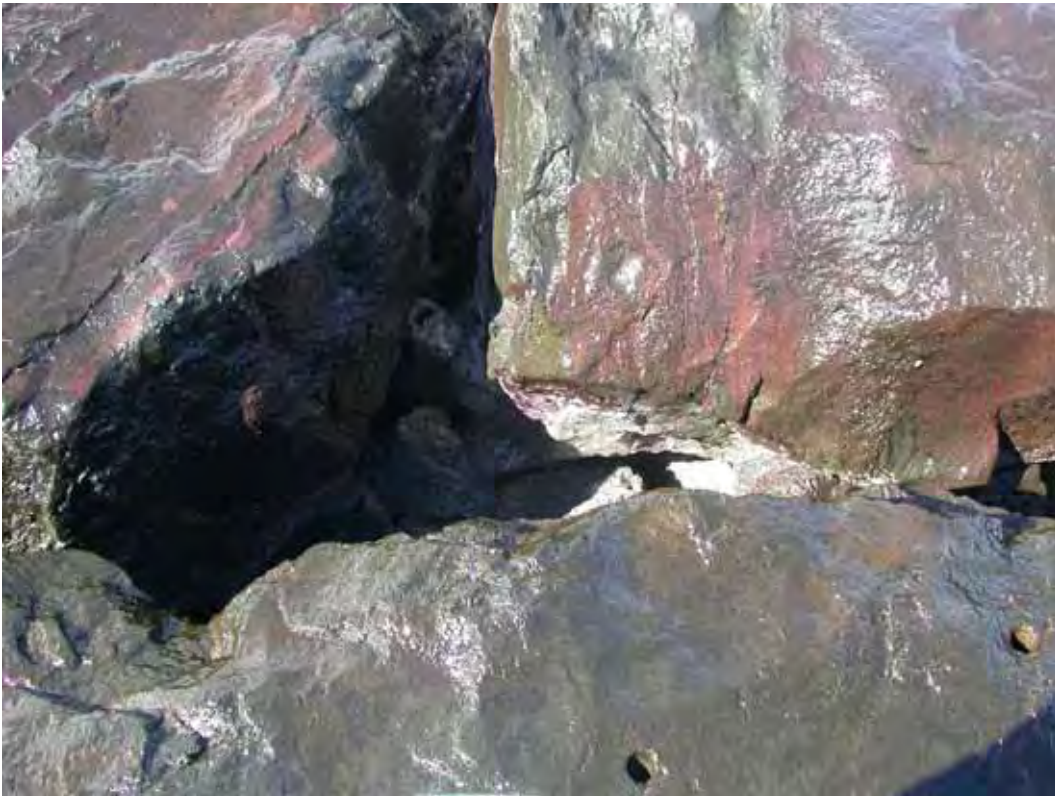
Figure A51. Damage location 55, sta 57+35, void at crest (10 ft x 2 ft x 4 ft).

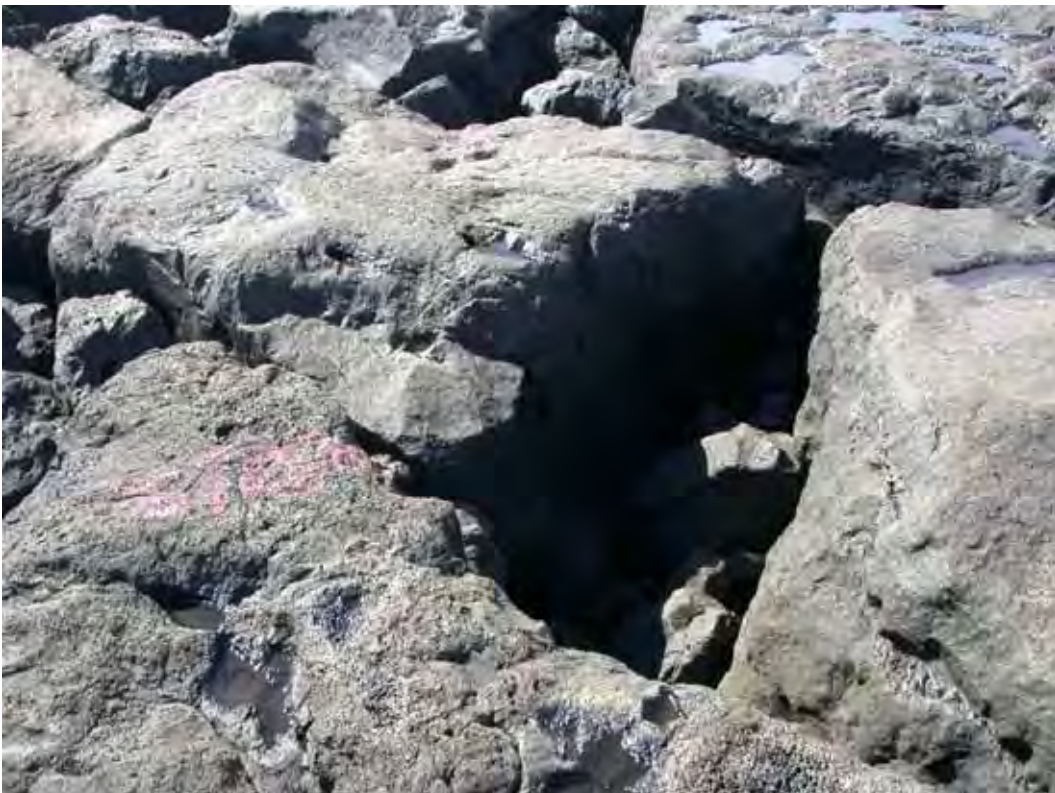
Figure A52. Damage location 56, sta 57+58, void at crest (2 ft x 4 ft x 3 ft).

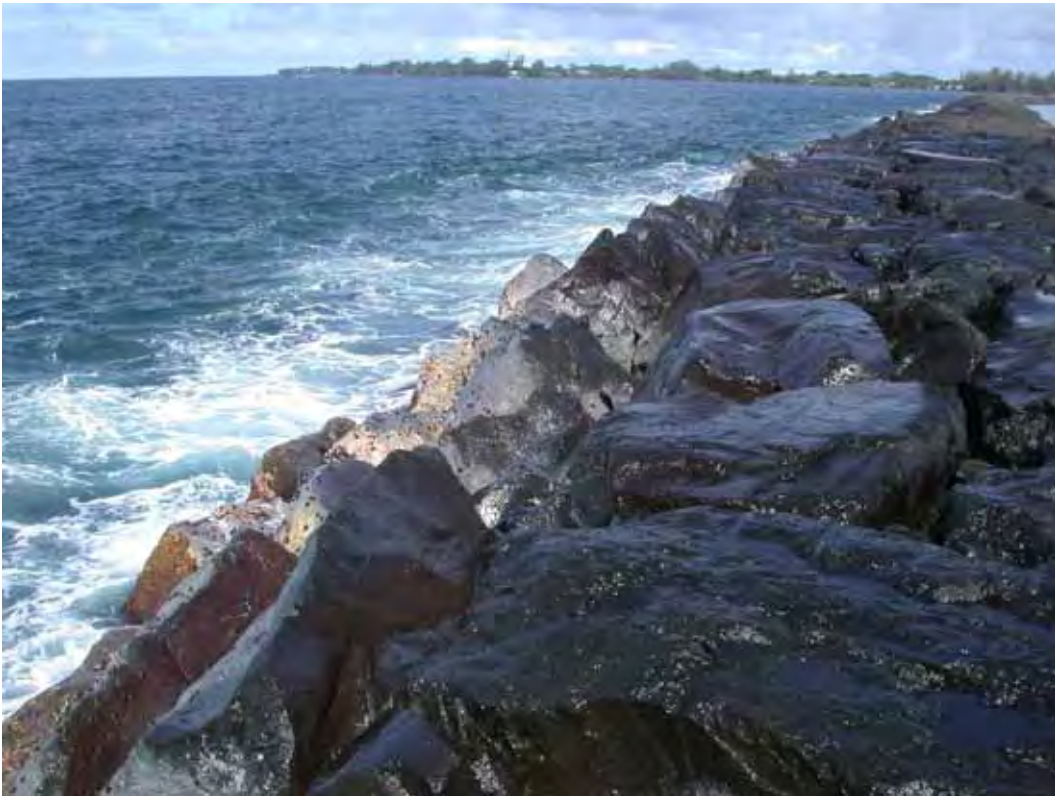
Figure A53. Damage location 57, sta 55+56-and 59+30, ocean side, settling at crest.

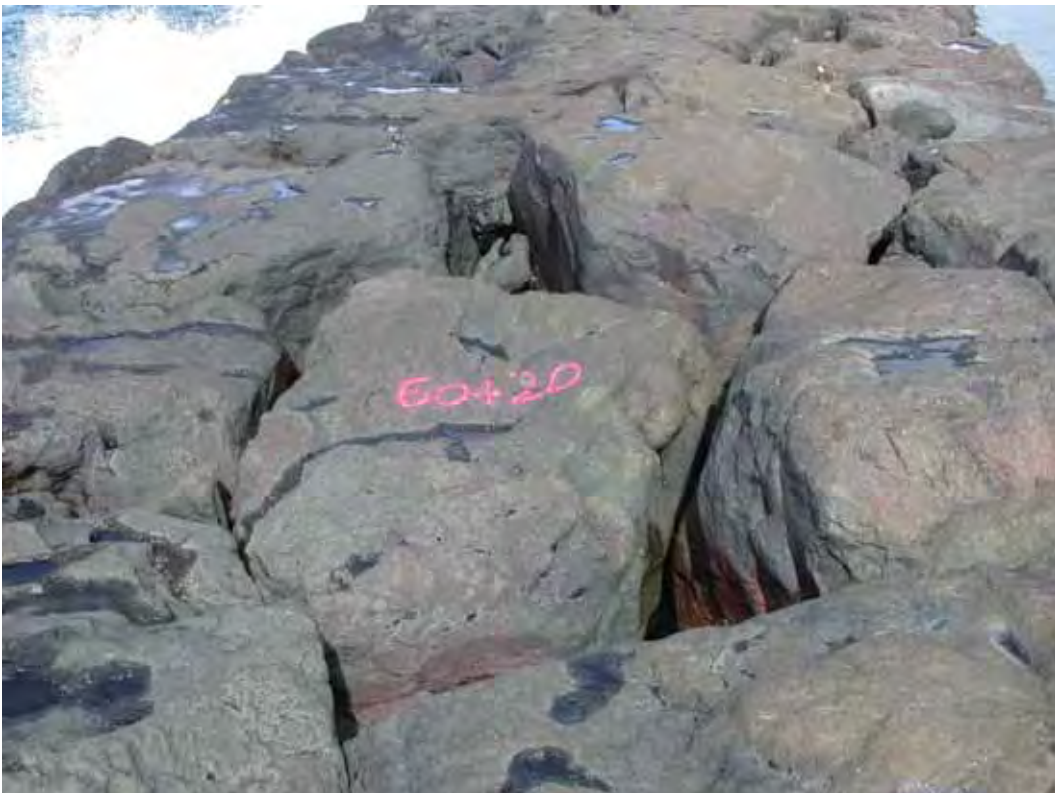
Figure A54. Sta 60+20, harbor side, unmarked copper disk.

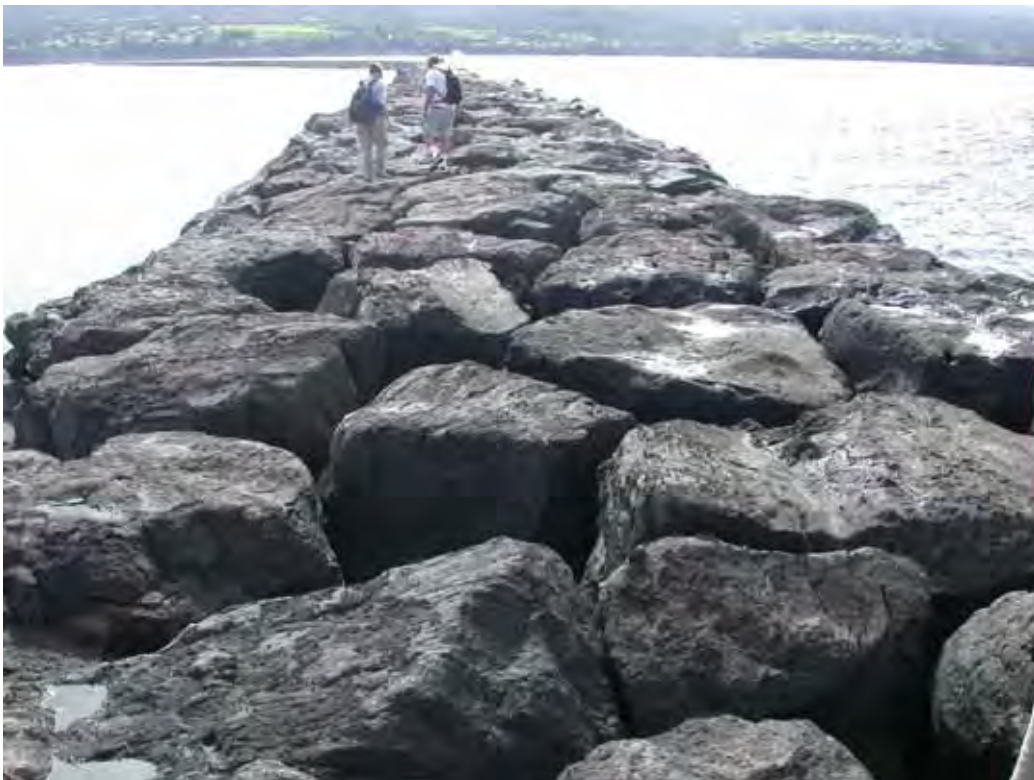
Figure A56. Damage location 60, sta 61+13-and 61+50, numerous armor stone separations and voids.

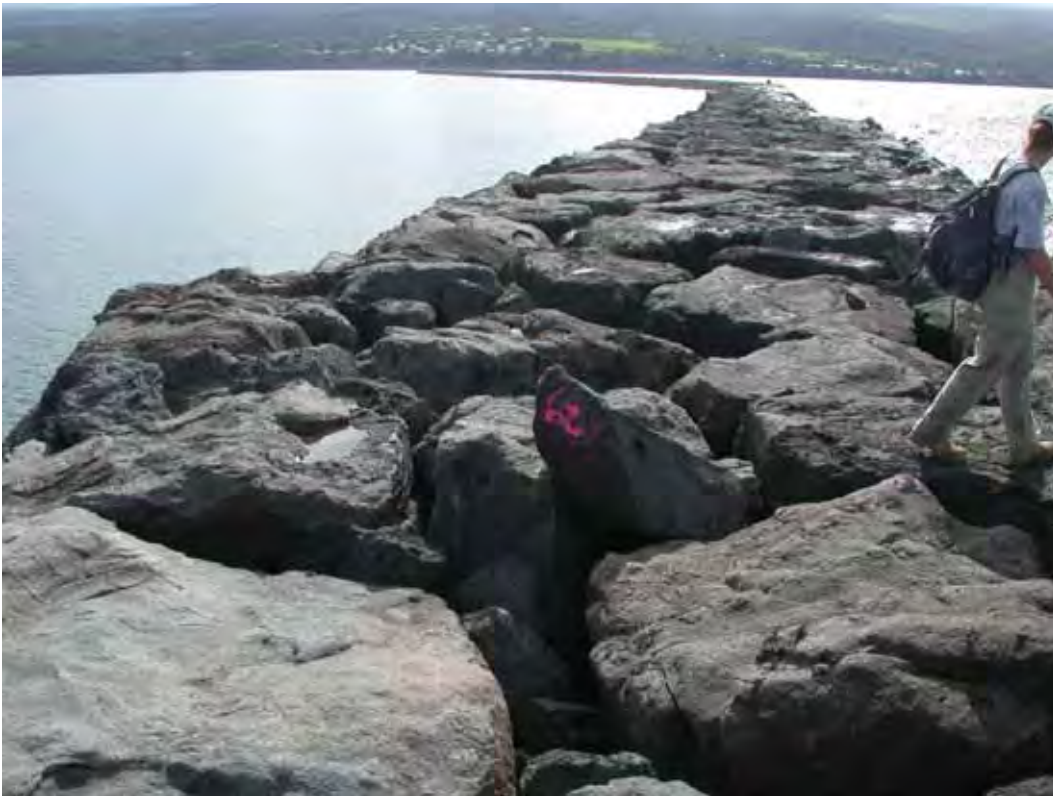
Figure A57. Damage location 61, sta 62+00, perched stone.

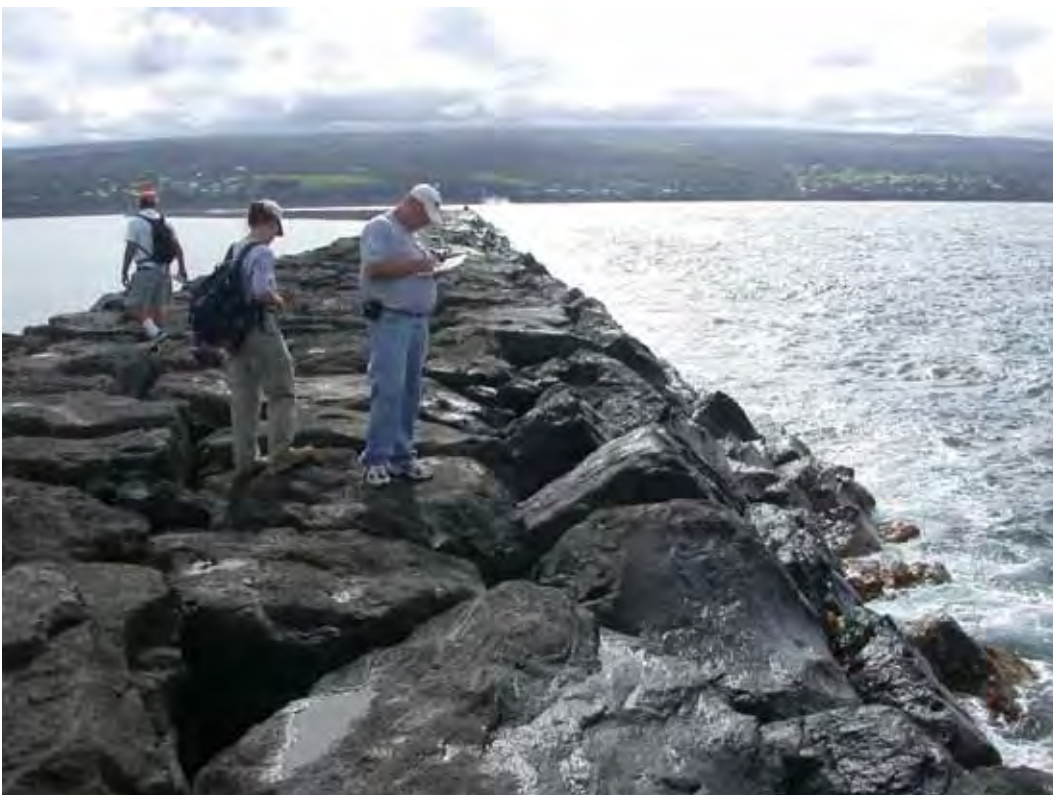
Figure A58. Damage location 62, sta 62+30 - 63+50, ocean side, hinge bowing out, bridging.

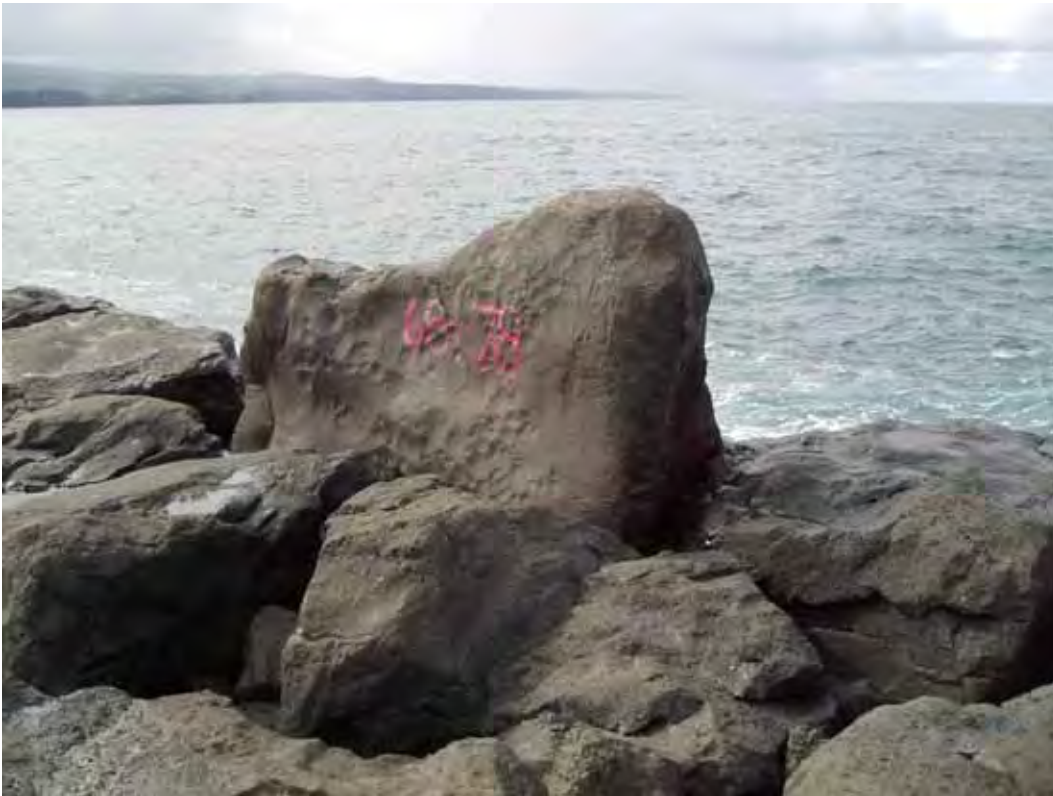
Figure A59. Damage location 67, sta 68+78, ocean side, perched armor stone "Tombstone."

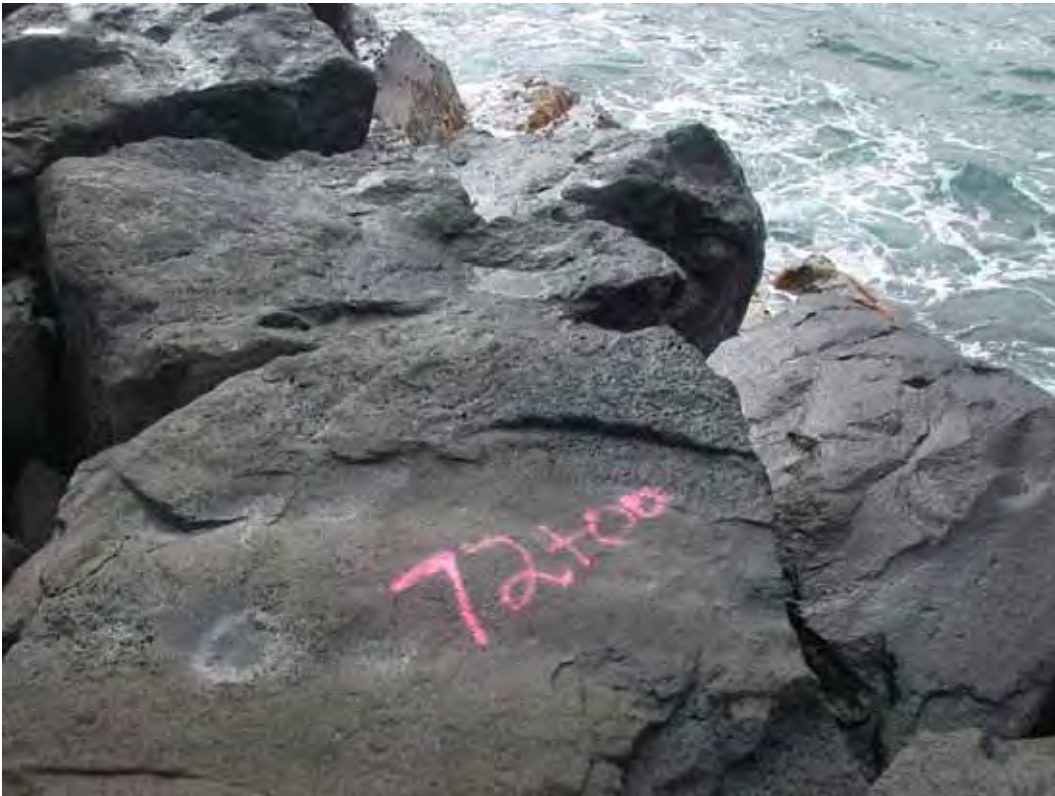
Figure A61. Damage location 70, sta 72+00, ocean side, hinge settling.

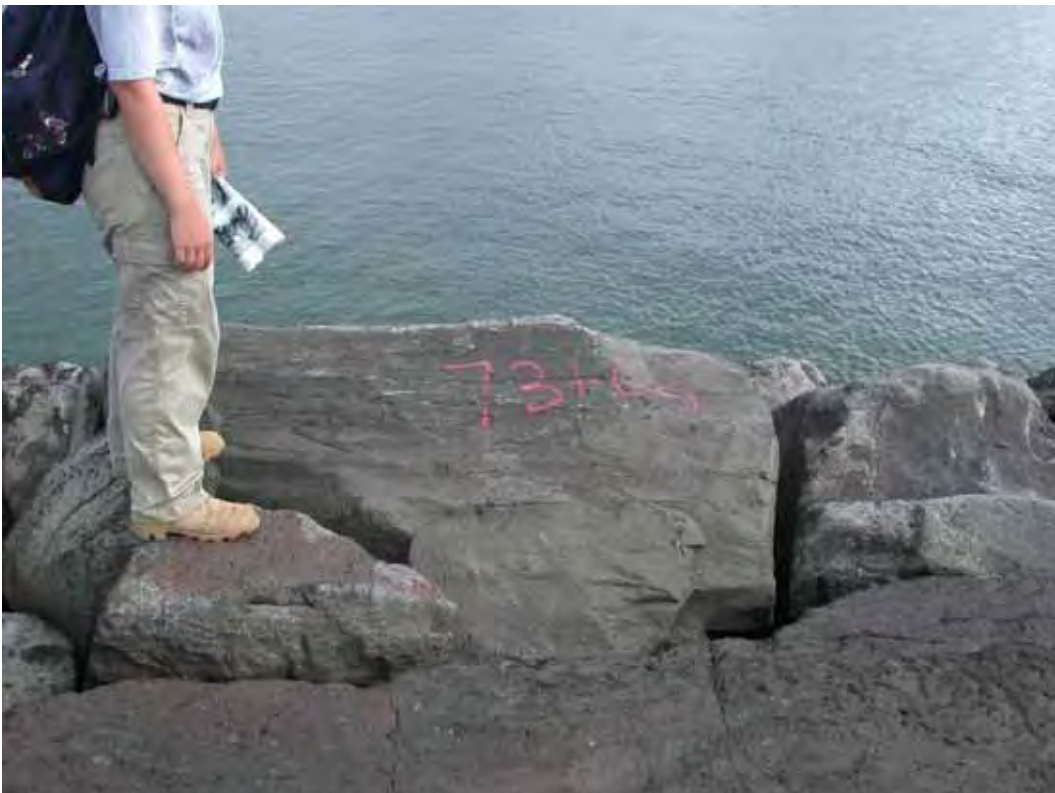
Figure A62. Damage location 71, sta 73+00, harbor side, slight settling of crest.

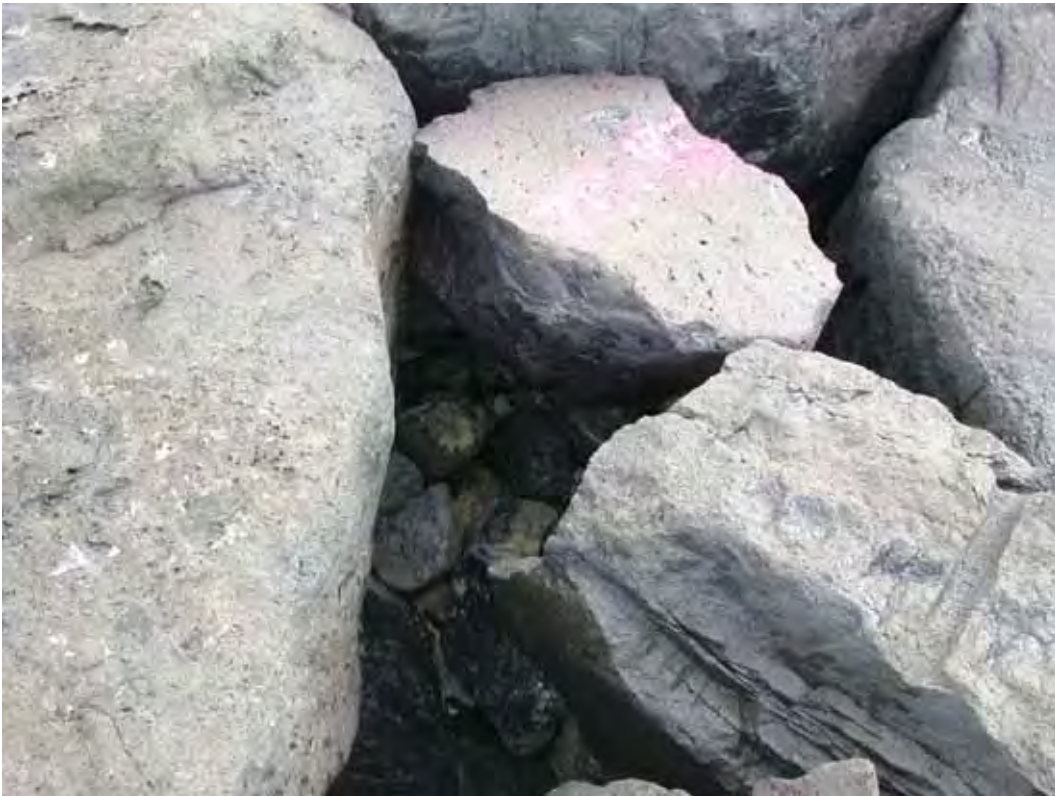
Figure A64. Damage location 75, sta 75+95, void.

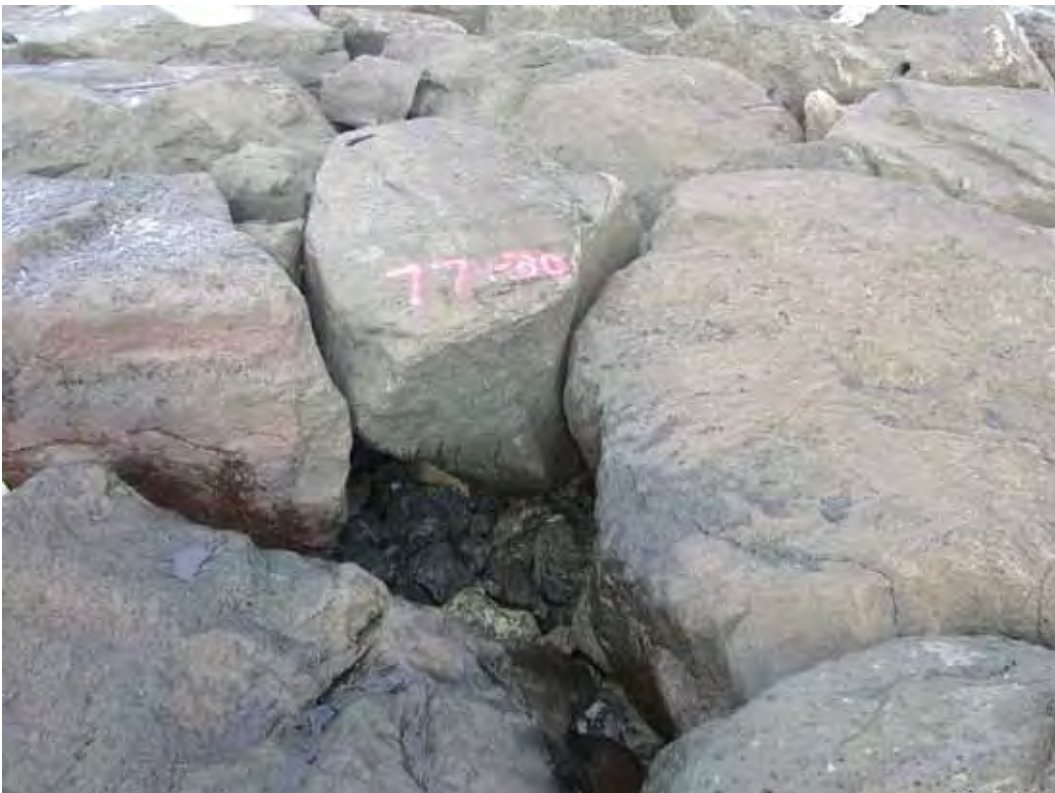
Figure A65. Damage location 76, sta 77+30, ocean side, bridging and settling.

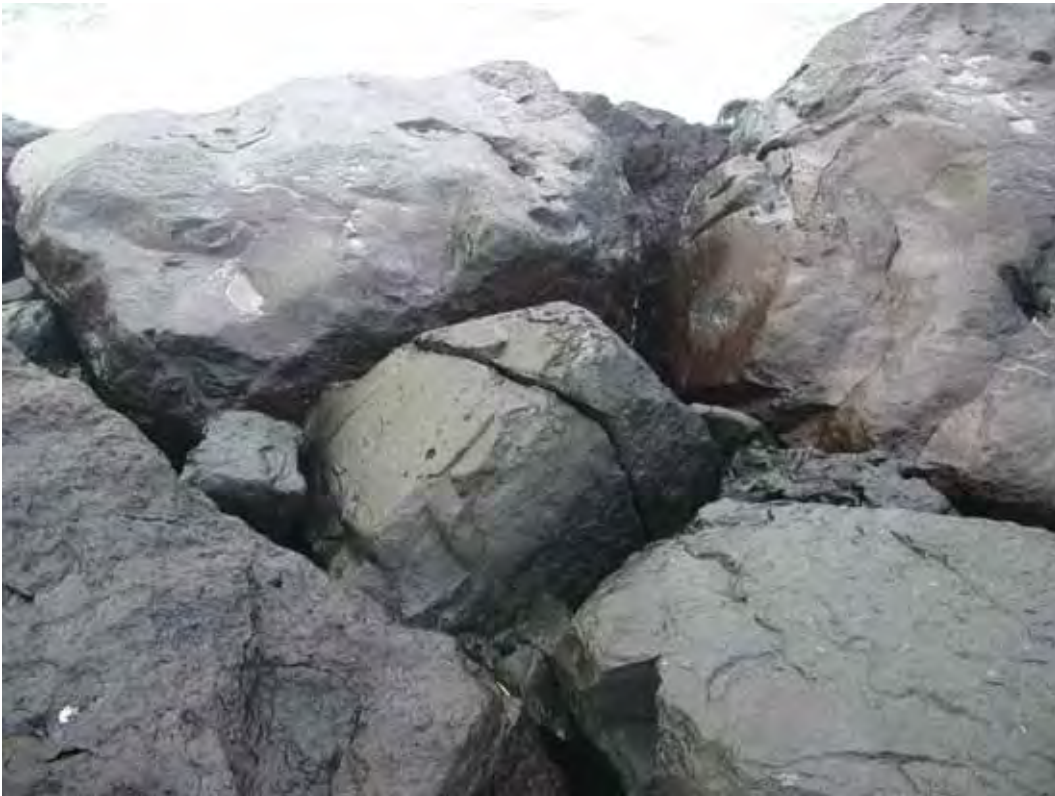
Figure A66. Damage location 77, sta 77+80, cracked armor stone on centerline of crest.

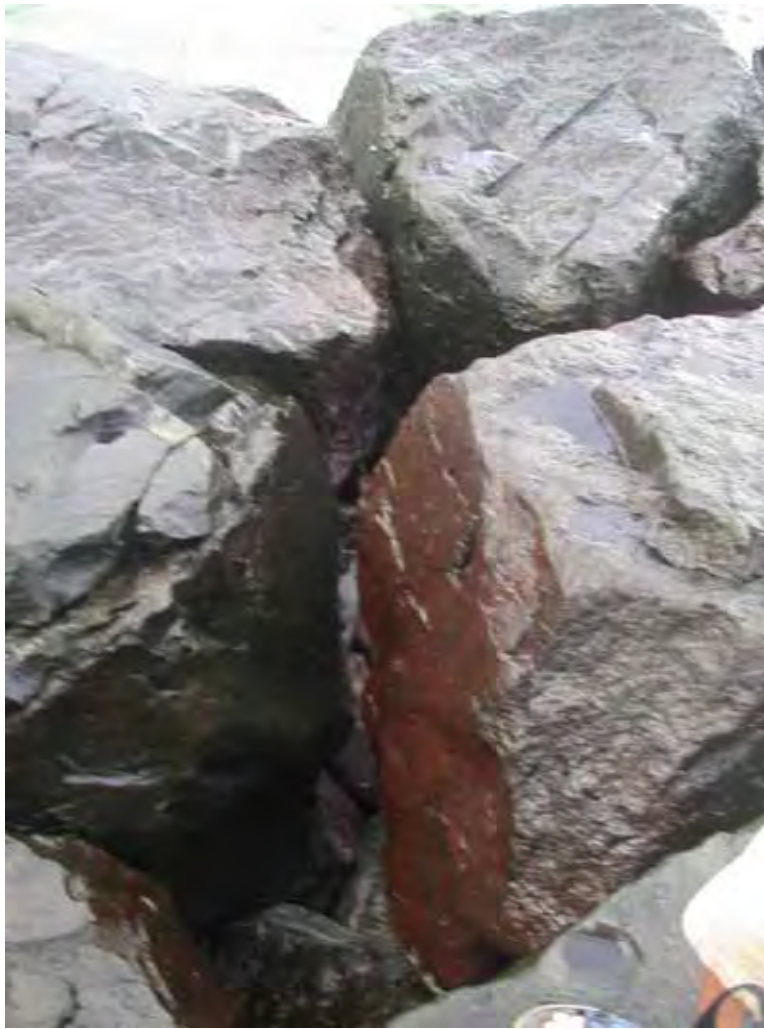
Figure A67. Damage location 80, sta 89+30, bridging.

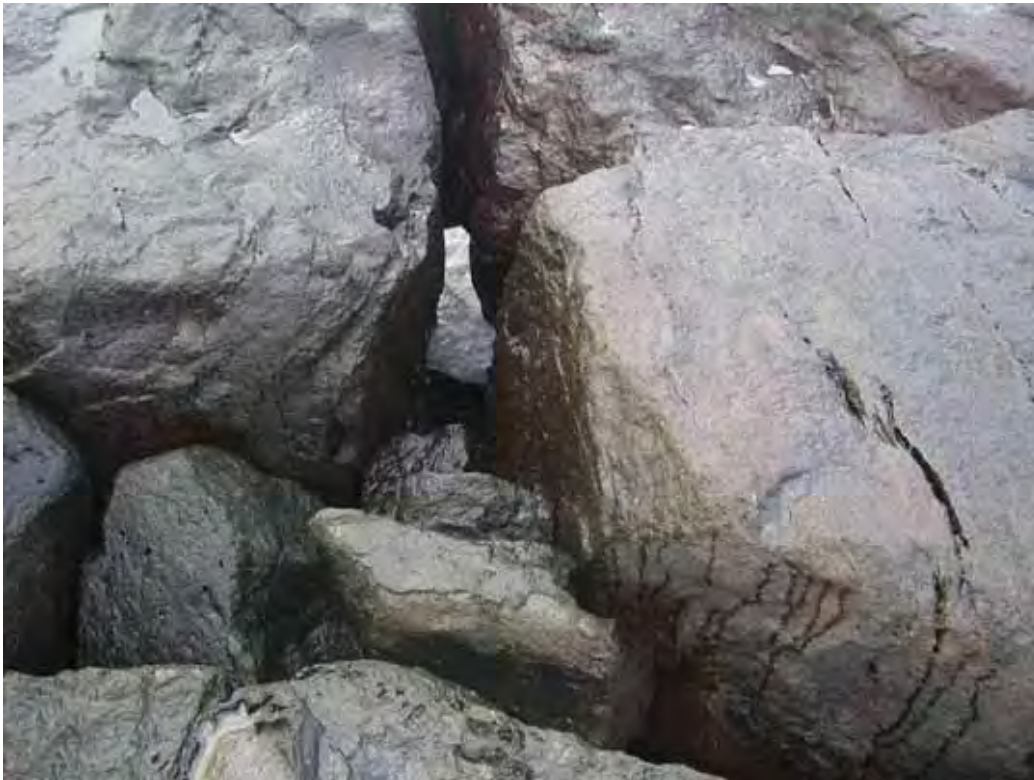
Figure A68. Damage location 81, sta 90+00, harbor side, aerial survey marker; settling at hinge; void at centerline of crest; bridging.

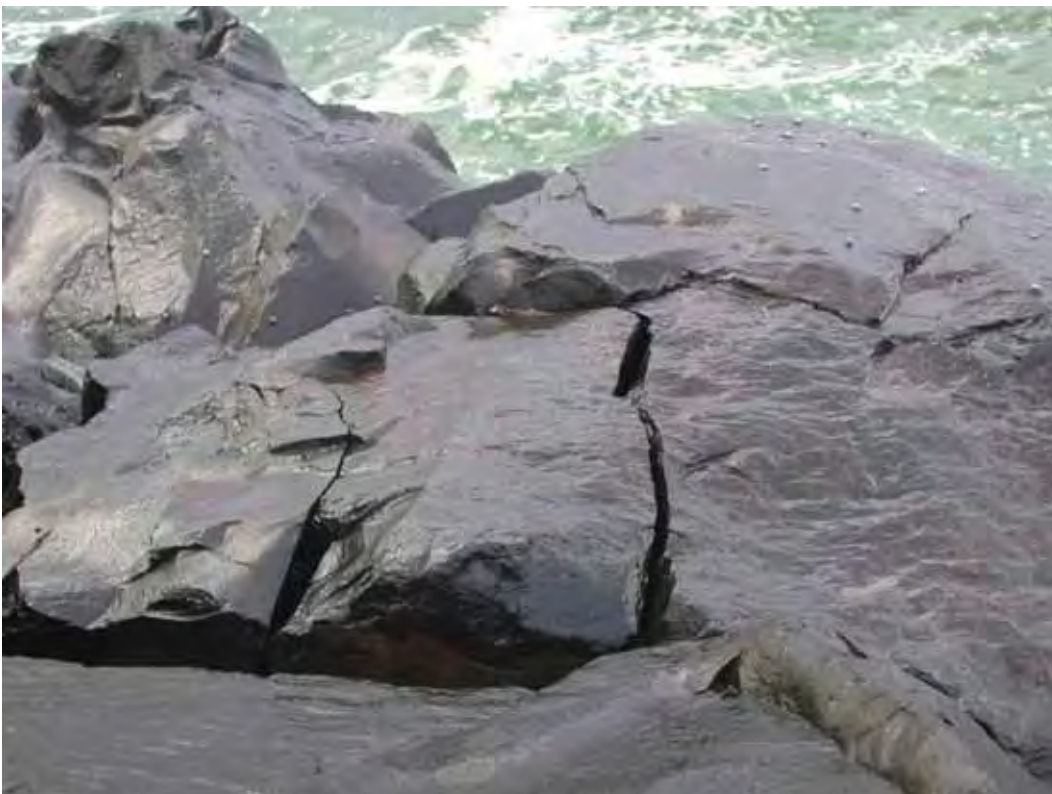
Figure A69. Damage location 82, sta 92+20, ocean side, broken armor stone and bridging.

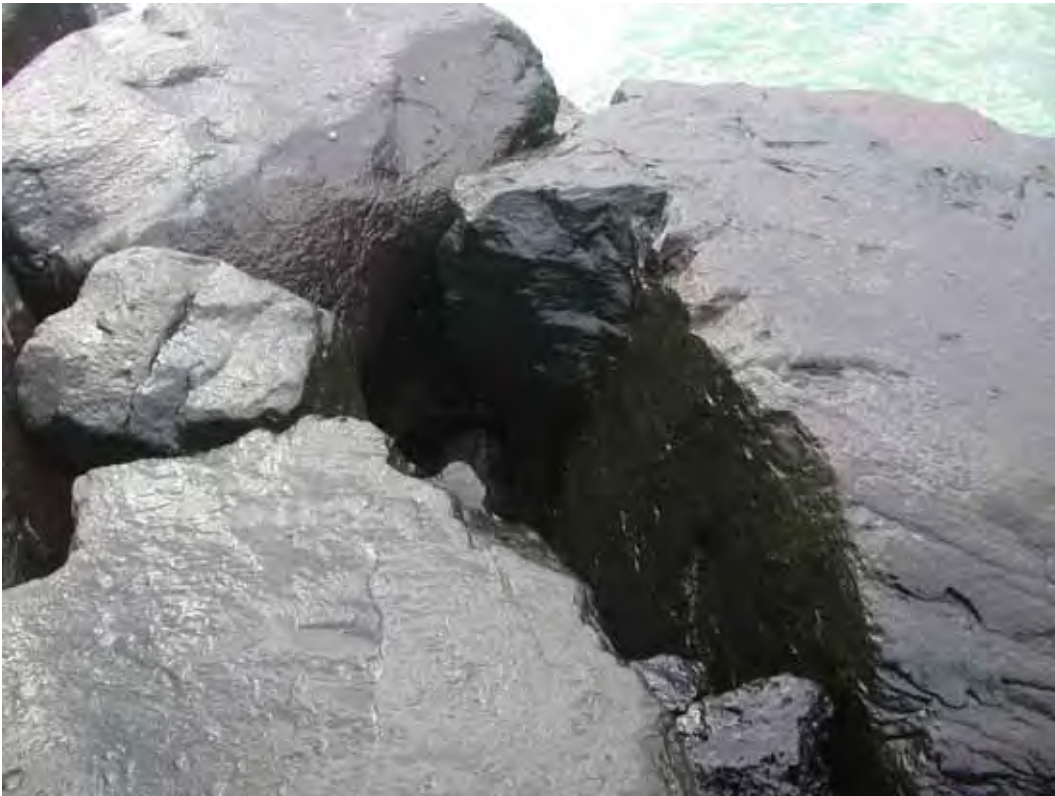
Figure A70. Damage location 84, sta 94+10, ocean side, void and bridging.

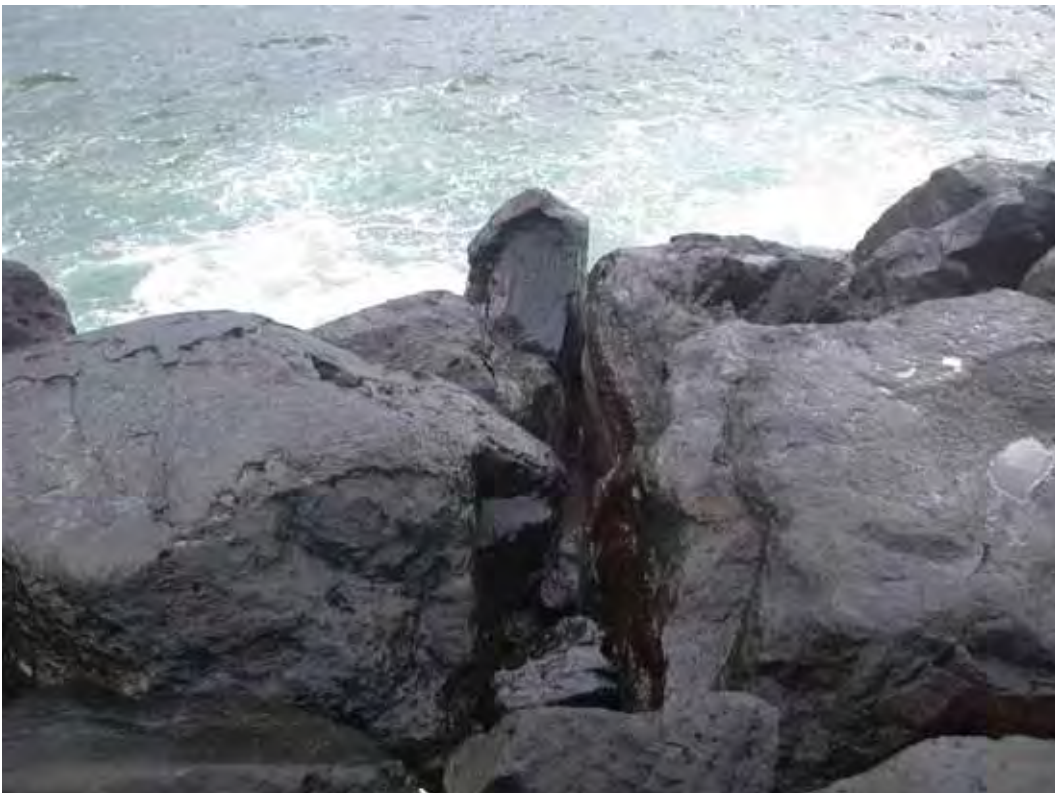
Figure A71. Damage location 85, sta 95+50, ocean side, separation of slope, flipped stone.

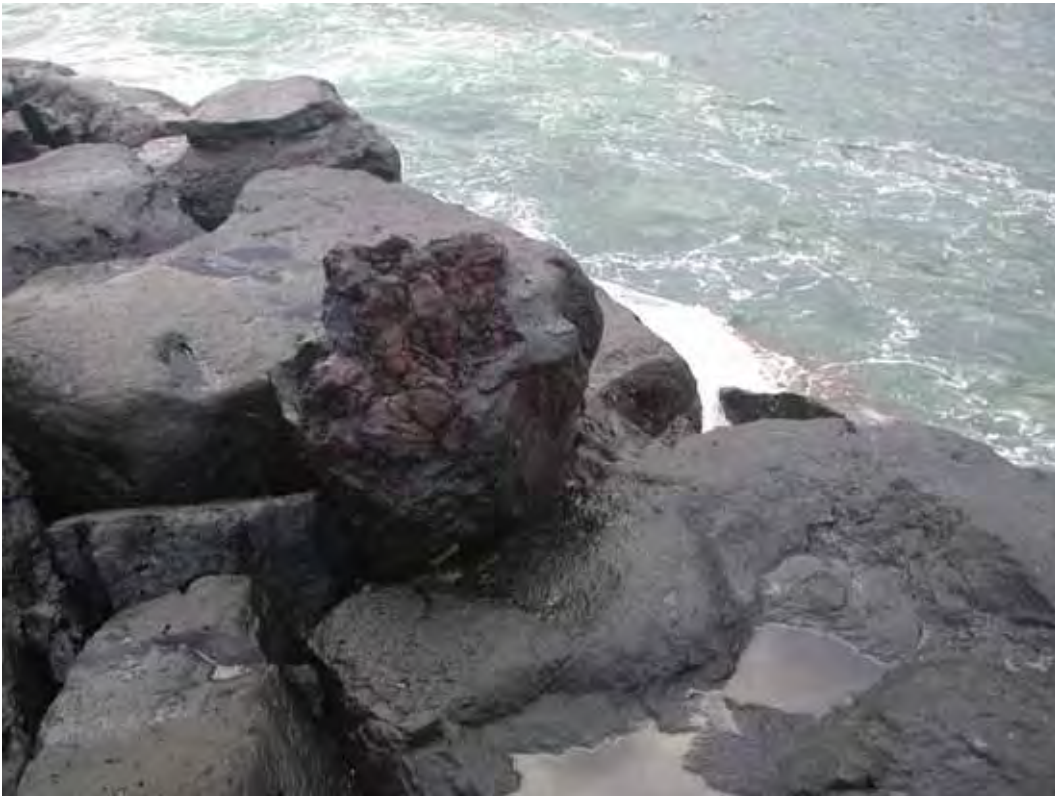
Figure A72. Damage location 86, sta 95+70, ocean side, flipped stone at hinge.

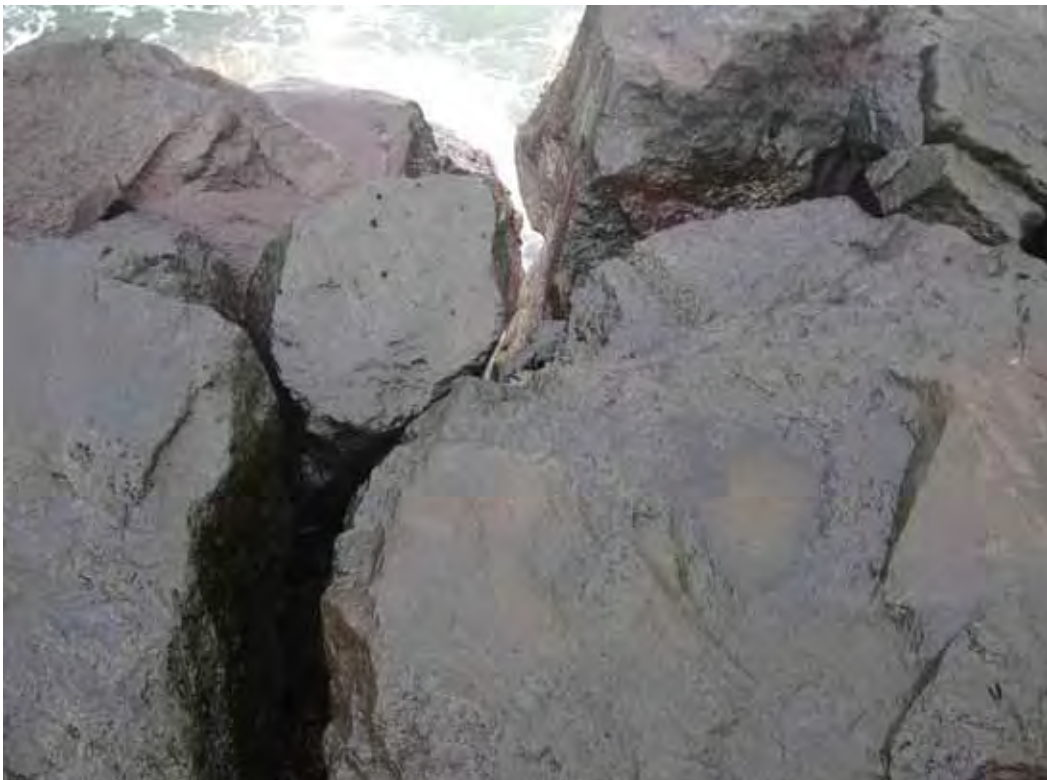
Figure A73. Damage location 87, sta 98+50, ocean side, 2-ft-wide fissure extending from crest down to waterline.

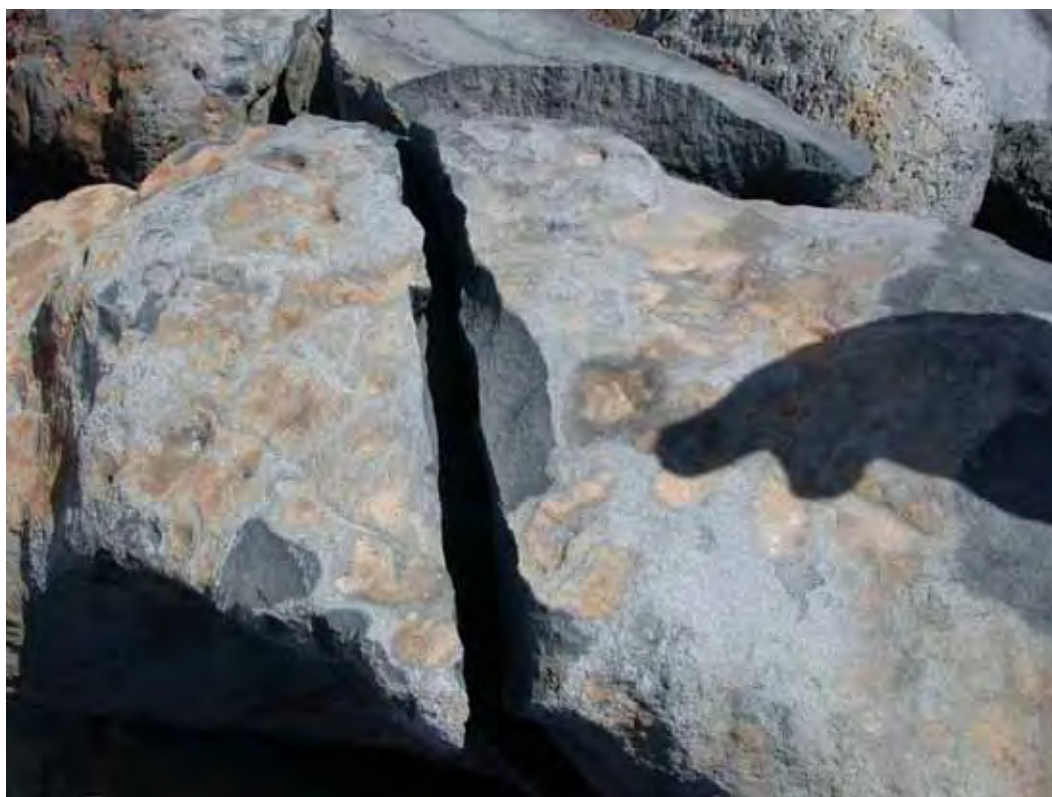
Figure B1. Damage location 1, sta 3+08, harbor side, broken armor stone.

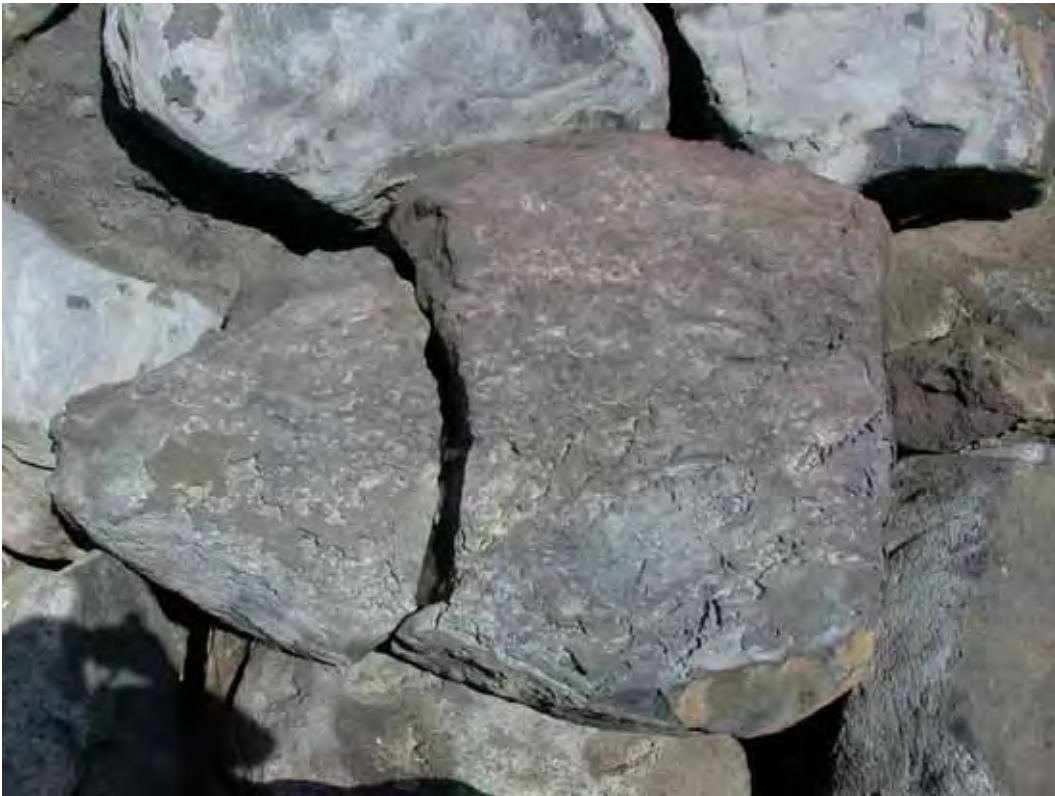
Figure B4. Damage location 9, sta 21+60, crest, broken armor stone.

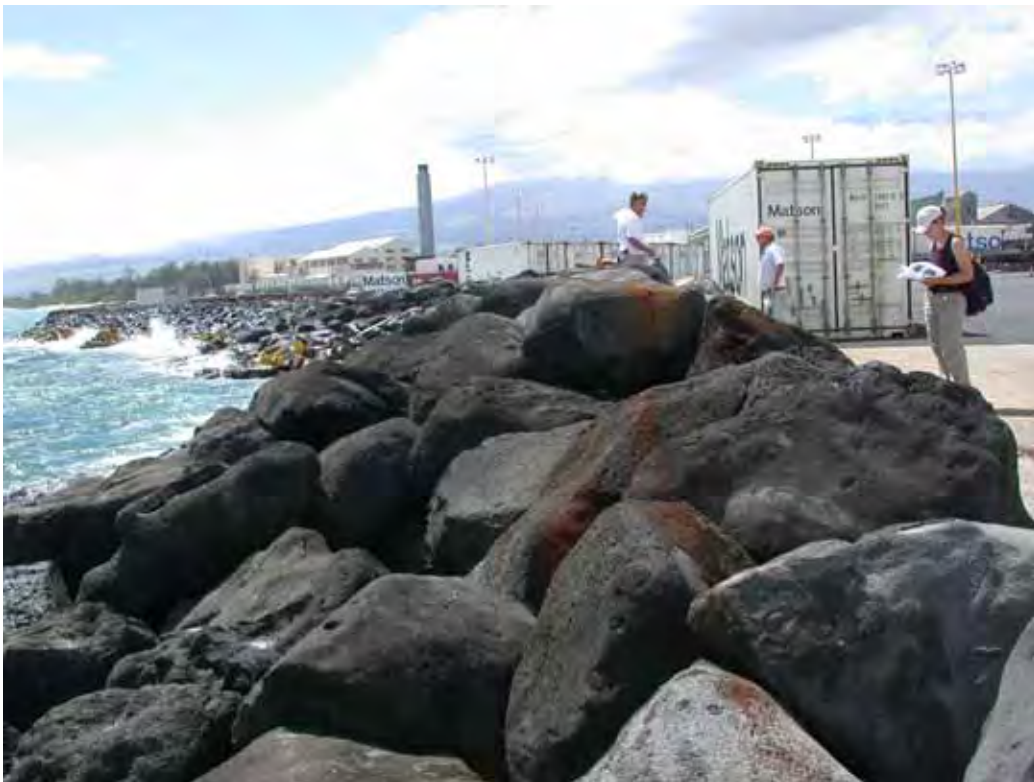
Figure B5. Damage location 10, sta 22+40, transition of repair zones, crest elevation drop, monitor side slope settling.
